NRL/MR/6180--04-8742

Performance of Fire Protective Coatings Subjected to DC-ARM Wartime Scenario Fires Aboard Ex-USS *Shadwell*

January 16, 2004

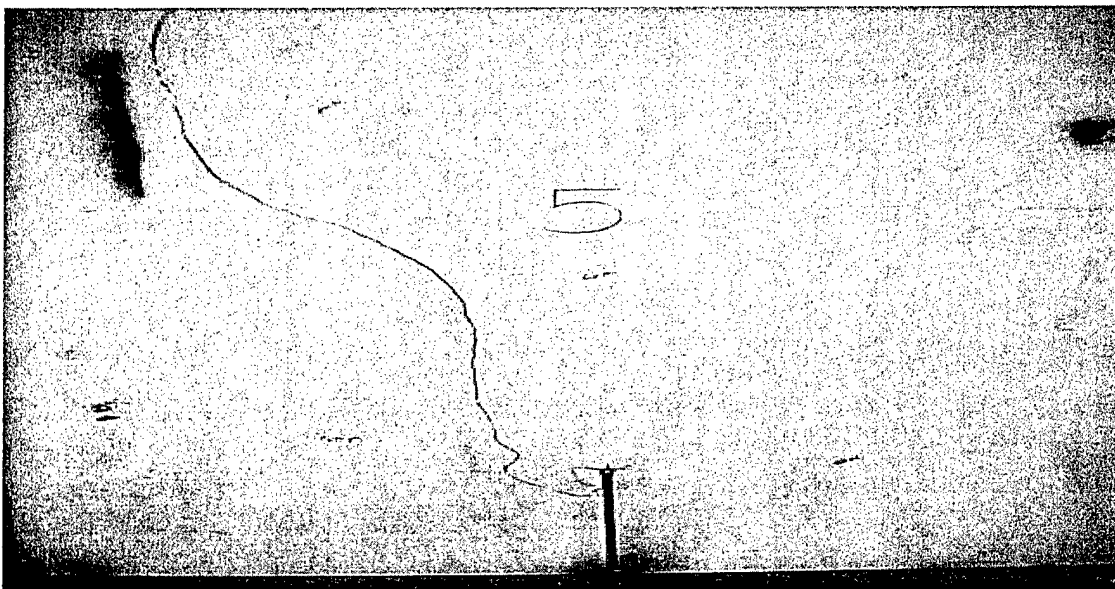
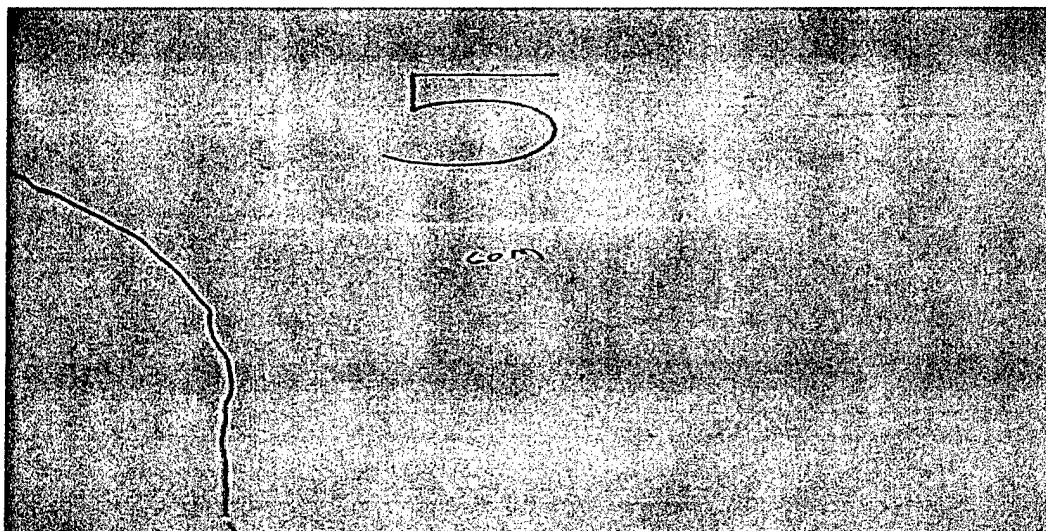
Figures 20-24 are before and after pictures of the coating, *Fire Barrier-2*, applied to the aft side of panel 5. This panel was directly in front of the BRAVO pool fire. The coating would have been subjected to direct impingement of the flame throughout the entire time the heptane pool was burning. A small area of this coating, directly above the fire pan, showed some degree of intumescent response but not of the scope and uniformity that would have been expected. The coating surface was a mixture of hardened crust, blisters and a shallow, intumescent char. The dominant response of the coating on this panel was blistering. There was some post test indication this coating suffered minor cracking during the fire.

Figure 20. Fire Barrier-2, Pre-Test Condition

Figure 21. Fire Barrier-2, Pre-Test Close-Up

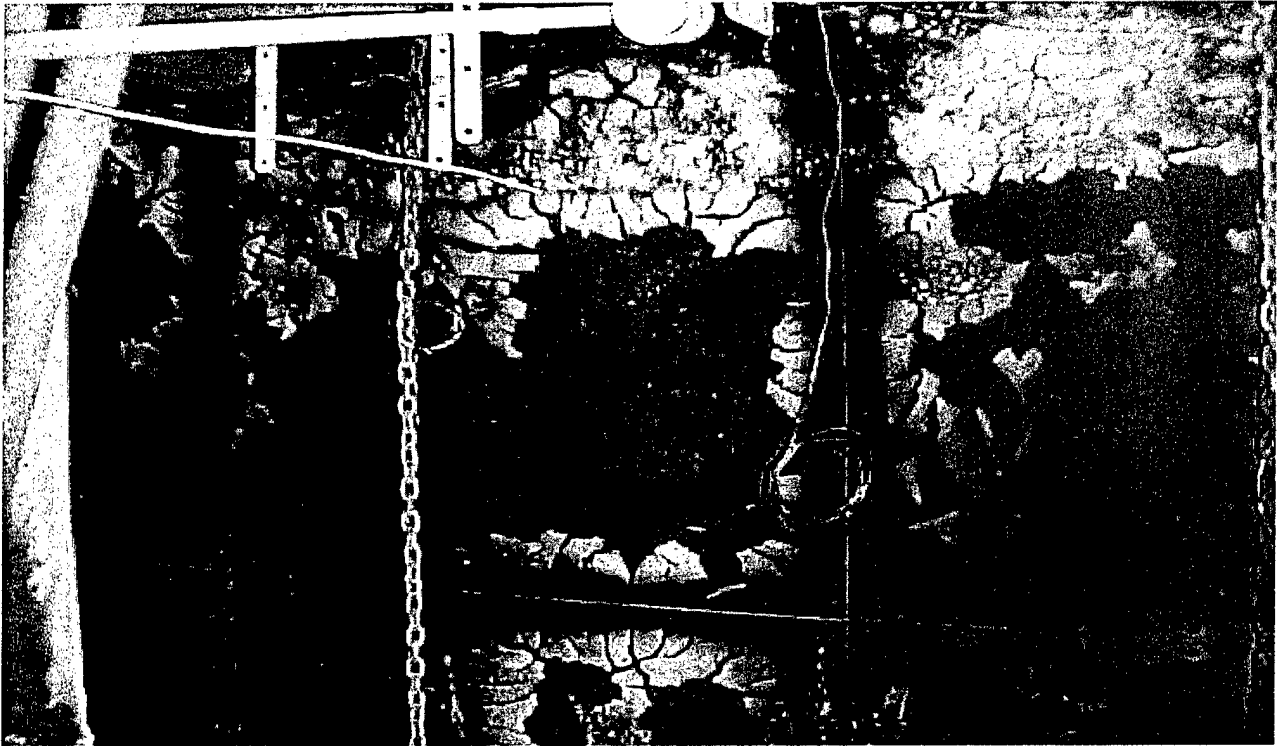
**Figure 49. Condition, Navy Stock Paints Exposed
To 1.5 MW Wood Crib Fire**
